## **SPECIAL INSPECTION REPORT.**

- 01.1 Job No 311 Refer 6761
- 01.2 This report is presented to give an honest & practical overview on the property at 311 Lehmans Road Rangiora / Fernside 7471. This report is commissioned by Sandy Purvis.
- 01.3 Lot 6 DP 83612 BLK VI Rangiora SD
- 01.4 The inspection of the property was carried out on the 30/6/2015
- 01.5 The inspection will cover:
  - \* A visual inspection only of the general condition of the property as a whole.

Date of Inspection:30/06/2015

Site Address: 311 Lehmans Rd. Rangiora

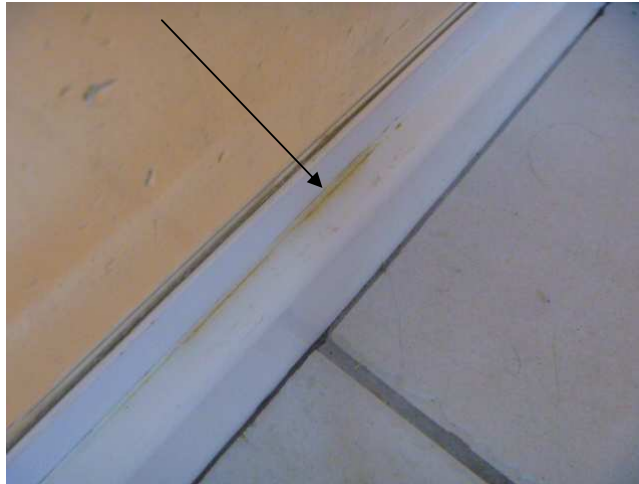
- 15.4 The dual flush cistern is operational; the top to the plastic seat is cracked.
- 15.5 The fibreglass shower base, 1 piece acrylic wet wall lining, easy clean trap, screens and pivoting door are in good order the trap needs cleaning out There is a leak from the bottom of the shower screen approximately ½ way along that will need resealing. The shower mixer is operational with good hot water pressure.

Leak from shower screen

- (1). The leak from the bottom of the downstairs shower screen needs sealing and both the easy clean traps need cleaning out. These need to be cleaned on a regular basis. The hot tap in the pedestal basin needs to be tightened and the bath tap handle fixed securely in place as this can fall off and damage the bath.  
The leaks from the corners of the shower in the self-contained unit need to be resealed to prevent leaking.
- (2). The hot water cylinder needs to have seismic straps fitted, 3 seismic straps are required for this size of cylinder and were required when installed

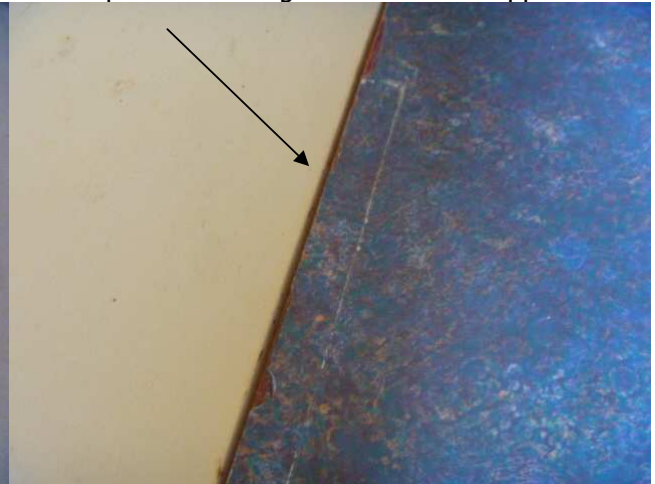
bench top needs sealing to wall and is chipped

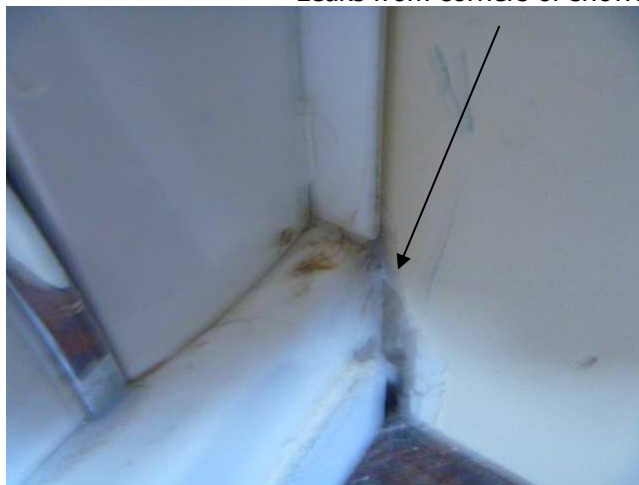
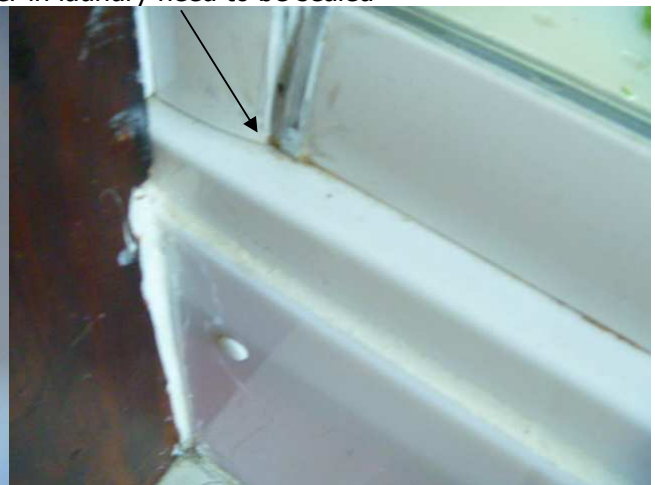
Leaks from corners of shower in laundry need to be sealed

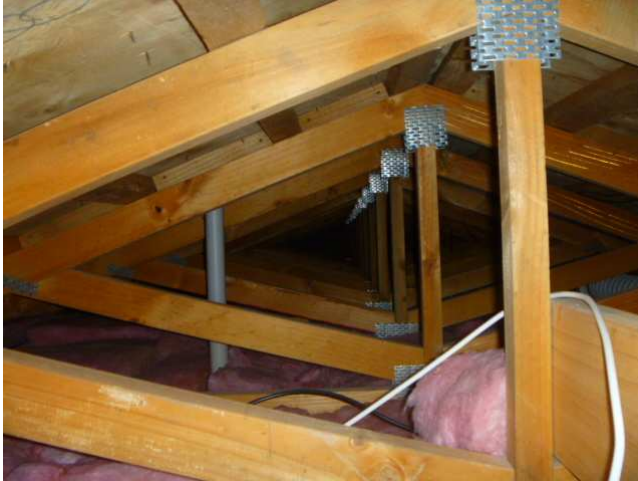
- 21.1 This is a professionally manufactured machine pressed nail plate truss roof and ceiling structure of Pine in good order.
- 21.2 Due to the restricted roof height access is very tight and limited.
- 21.3 The insulation seen appears reasonable and cleared from around the enclosed recessed halogen lights; 2 seen.
- 21.4 The hot water cylinder was originally fed by a polythene header tank but this has been disconnected.
- 21.5 The roof shingles are laid over plywood sarking with no sign of leaks.
- 21.6 The wiring is TPS with a circuit breaker distribution board in the main laundry; this has 1 RCD.

Roof space

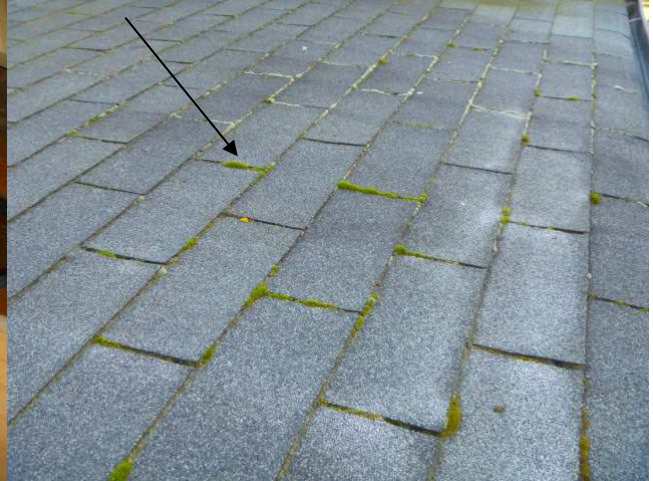
roof tiles need moss treating

- (1). The single lever faucet in the kitchen leaks and needs a new washer kit or replacing.
- (2). The gas hobs need to be serviced as the electronic ignition did not appear to work?
- (3). The roof tiles will need moss treating.
- (4). Due to the damp and moss around the bottom of the cladding and roof flashings the timber will rot in time. The bottom batten could be removed and the plywood carefully cut back to have a 35mm gap between the bottom of the timber and flashings, this could also be done above the joinery head flashings as well.  
The horizontal joints in the cladding will also need to be sealed and maintained as these can let water in. A flashing would be required if built by today's standards.
- (5). The stormwater risers need to be cleared out and the stormwater checked.

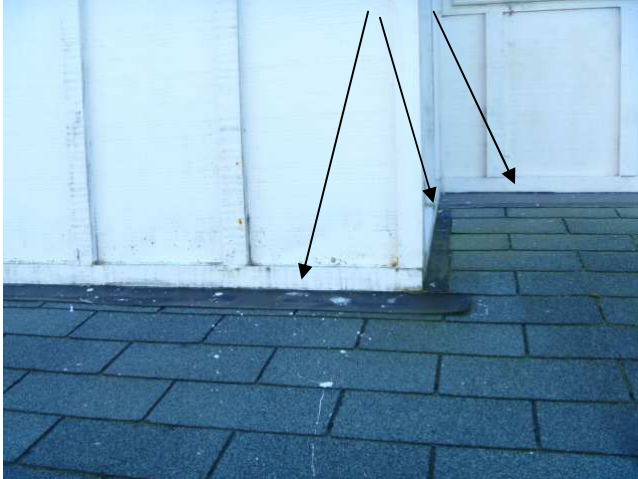
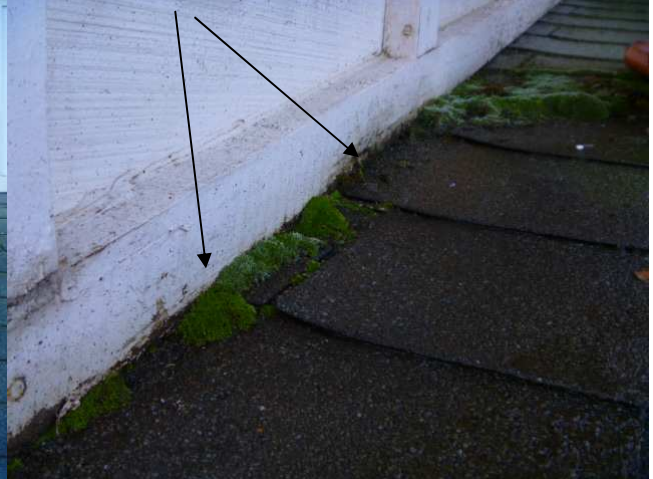
- 23.1 The painted fascia, bargeboards and plywood soffits are reasonable but due to be painted.
- 23.2 The upper cladding is plywood sheets with timber battens. The cladding is direct fixed to the framing with no cavity as was common practice at the time. The cladding has also been finished hard down onto the roof and roof flashings; a 35mm gap would be required if built by today's standards.

Cladding finished hard down onto roof flashing will rot in time

- 23.3 Due to the damp and moss around these areas the timber will rot in time. The bottom batten could be removed and the plywood carefully cut back to have a 35mm gap between the bottom of the timber and flashings, this could also be done above the joinery head flashings as well.

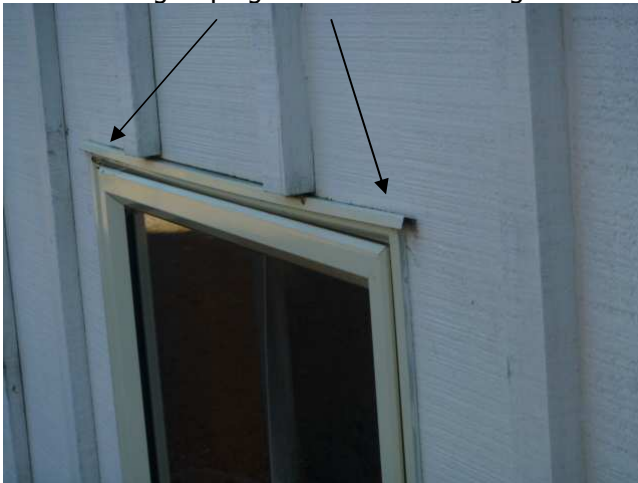
- 23.6 The aluminium joinery is in good order with head flashings run past the joinery but as the timber cladding has been finished hard down onto the head flashings some have been tilted back rather than sloping out and could cause problems over time. The cladding could also be cut back to have a small gap of 5mm-10mm between the bottom of the cladding and flashings.

Head flashing sloping back due to cladding

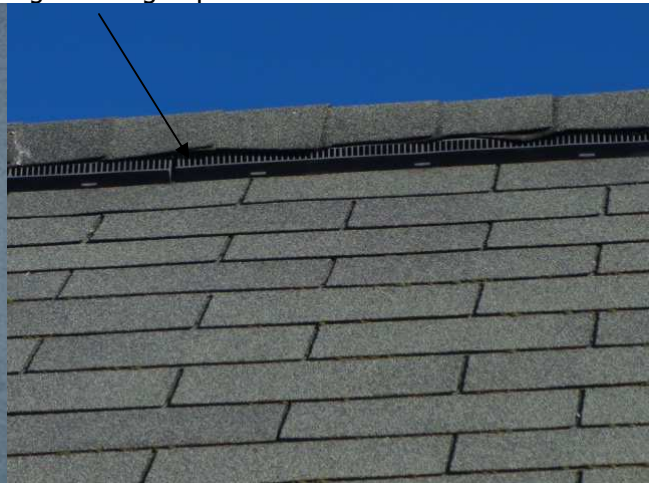
ridge venting in place

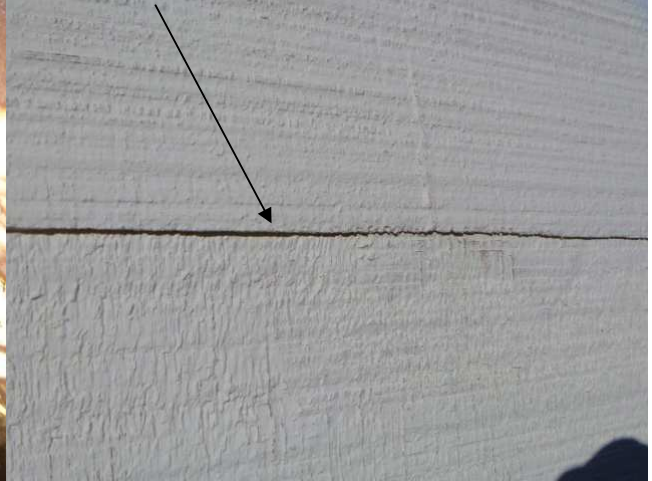
- 23.4 There are no flashings at horizontal sheet joins and this would be required if built today. Sealing these joins and painting will be required to prevent future problems.

horizontal cladding joins need sealing

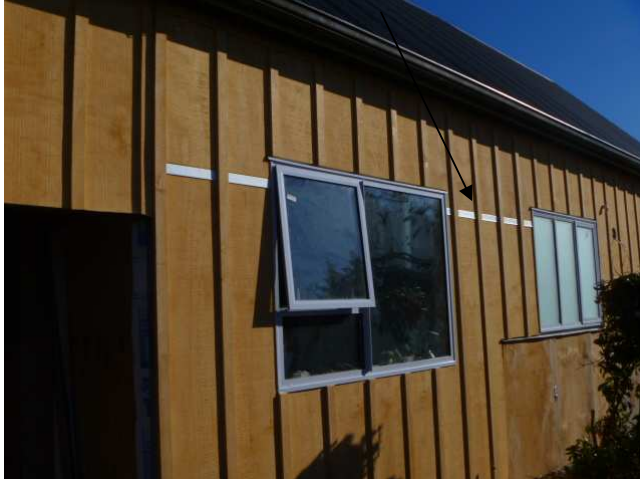
New cladding to barn, note horizontal flashing

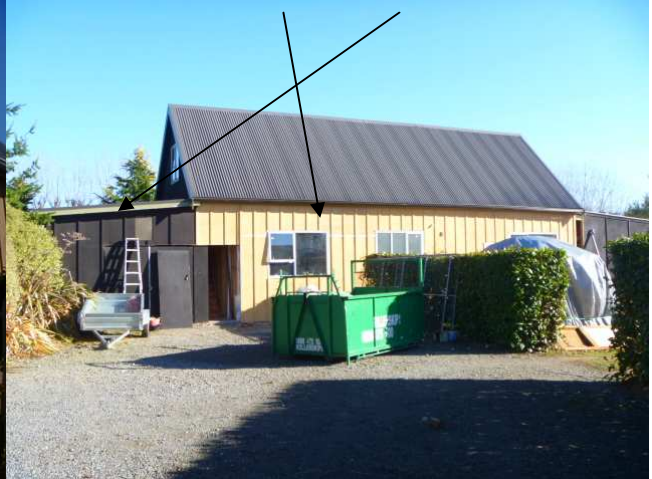
barn conversion to living with shed at the end

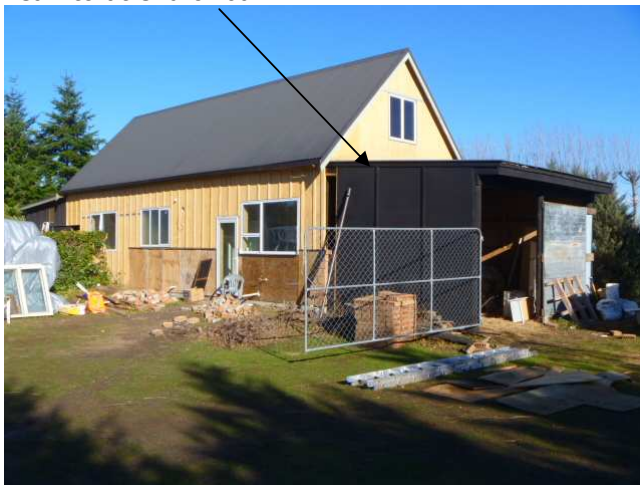
Lean-to at end of barn
